Innes McCartney

JUTLAND 1916

THE ARCHAEOLOGY OF A NAVAL BATTLEFIELD

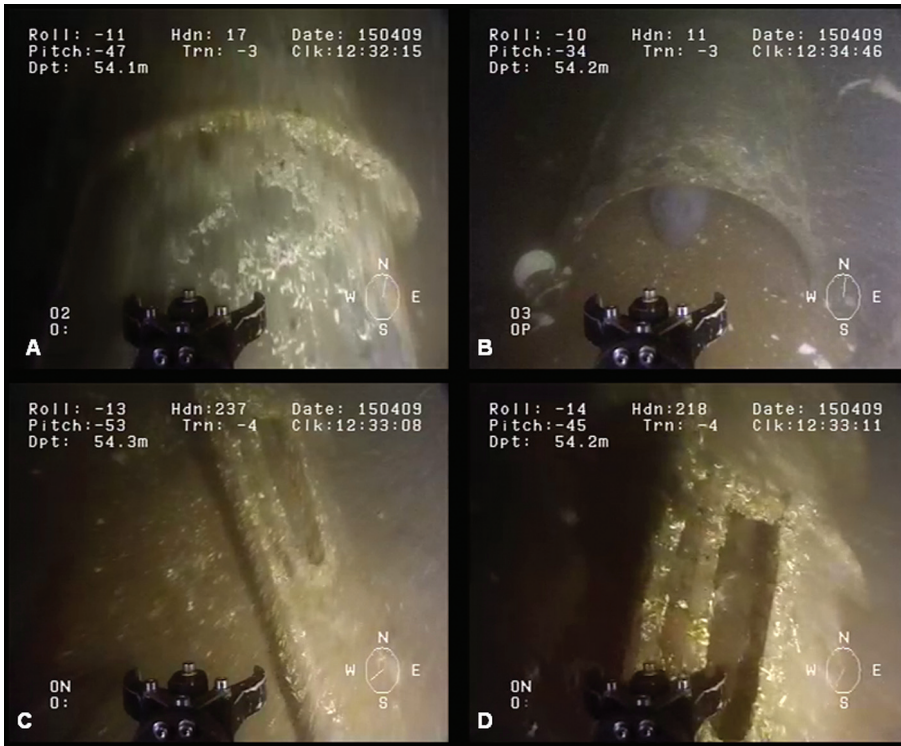
Fig. 7.10 Images of the torpedo tube seen on the wreck of SMS V48, which confirmed the wreck to be of German origin. (Pictures: McCartney/JD-Contractor)

tube had at least three of these. Image B shows the open end of the tube with a wolf fish living in it. The tube is over two-thirds buried in the seabed. The clinching evidence showing this to be German was the triangular window in the fore end of the tube, which covered the top of the warhead of the torpedo. This can be seen very clearly in C and D. No other evidence seen during the rest of the ROV survey conflicted with the view that this wreck was a German torpedo boat.

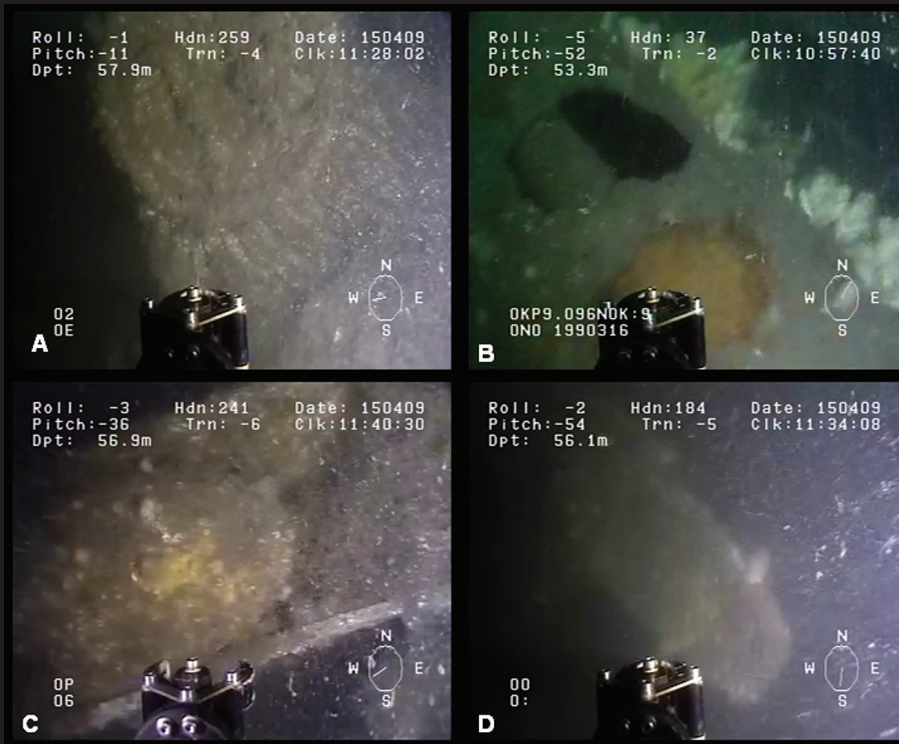
Fig. 7.13 Images of items seen during the ROV survey of the wreck of SMS S35, confirming the wreck to be of German origin. (Pictures: McCartney/JD-Contractor)

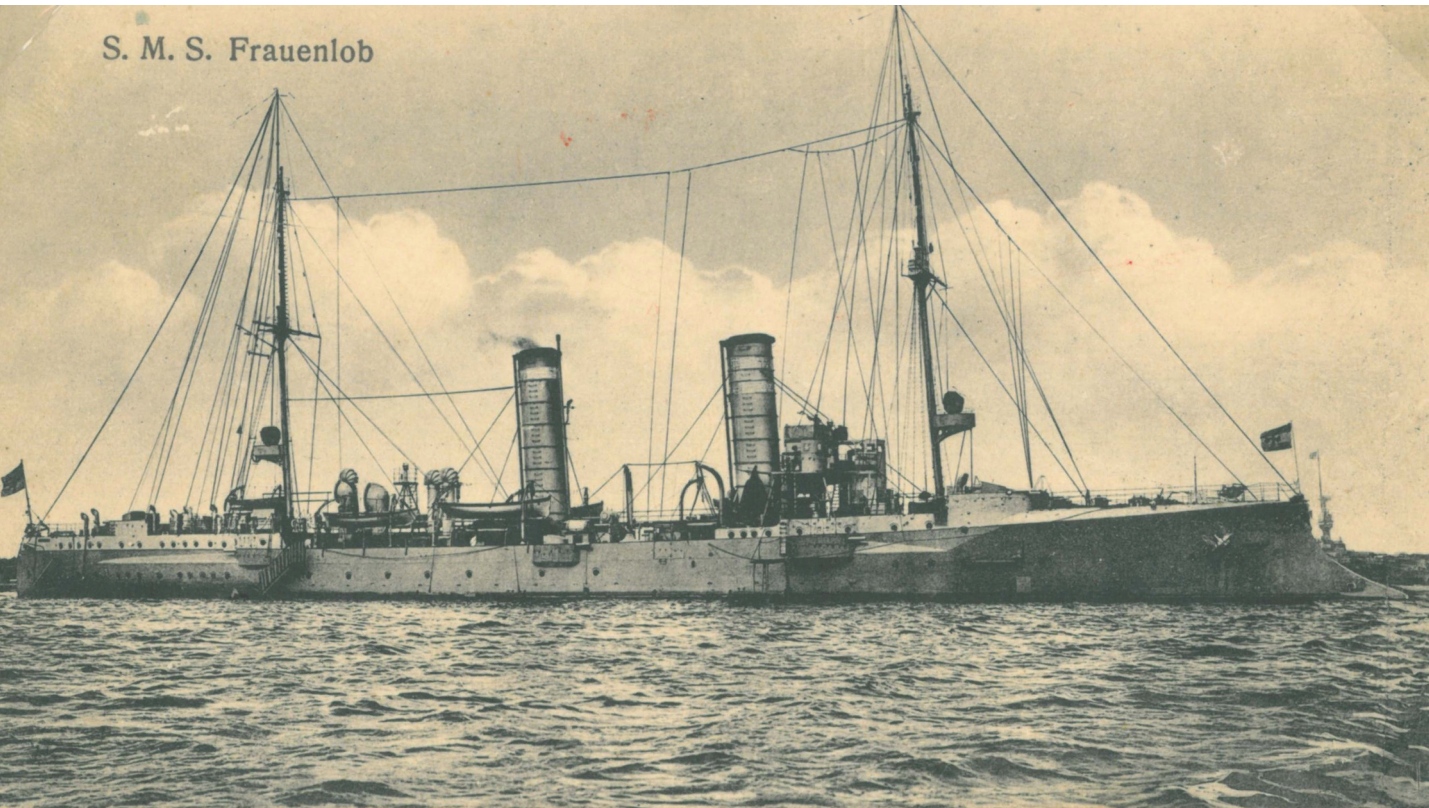
Fig. 8.1 SMS Frauenlob, as seen from the starboard side. The 4.1-inch gun turrets were arranged with a pair forward and aft and three along each side. Launched in March 1902, the ship had a displacement of 2,565 tons and a length of 328 ft, with ten 4.1-inch guns and two 17.7-inch torpedo tubes. (Picture: Archiv Deutscher Marinebund)

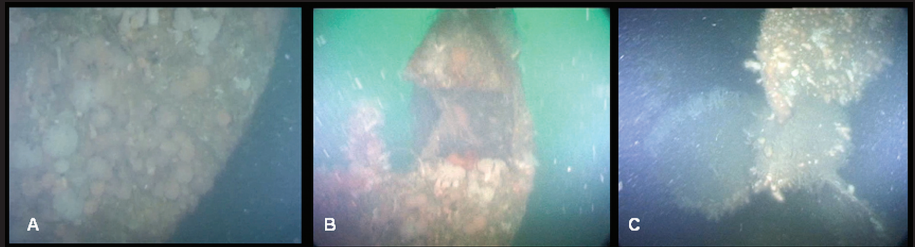
Fig. 8.6 The stern of the SMS Frauenlob wreck. The stern itself remains intact in a scour, as seen in A. B shows that the stern is the highest portion of this area of the wreck. C shows the port-side propeller to be unburied and intact.

During the dives in May 2001 the focus was on the stern portion of the wreck. This area too was markedly collapsed until the divers reached the stern itself. The stern plate stood higher than the rest of the wreck, again pointing to the collapsed state of the surrounding decks. A deep scour had built up on the starboard side, but on the port side one of *Frauenlob*'s 11ft diameter three-bladed propellers was clearly visible. Fig. 8.6 shows the features seen on the stern of the wreck.

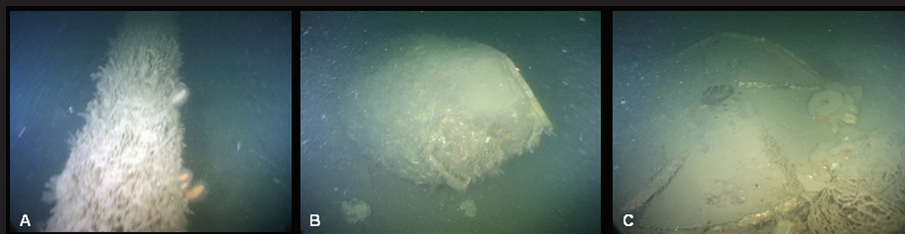
Fig. 8.7 Features on *Frauenlob*'s mainmast, as seen in 2001. A shows the mast itself, B the now somewhat folded remains of the searchlight housing and C what appears to be the base of the searchlight platform.

Another noticeable feature in this area was the remains of the mainmast, lying on the seabed on the port side of the wreck. In common with the German light cruiser wrecks in Scapa Flow, a swim along the pole of the mast brought me to the remains of the stern searchlight and its platform (Fig. 8.7).

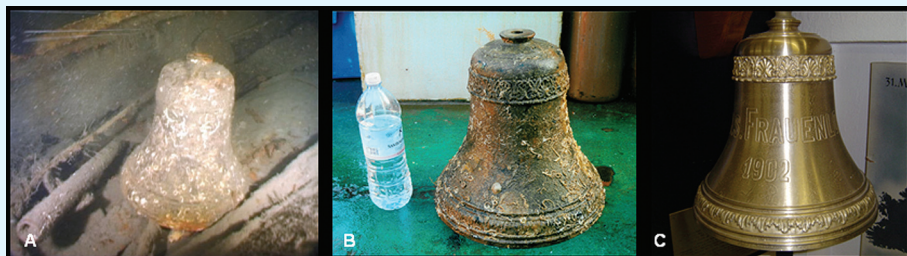
Fig. 8.10 From discovery to display: three images of *Frauenlob*'s bell, as seen A on the wreck, B when recovered and C as a conserved museum exhibit at Laboe.

The extent to which this wreck is a significant archaeological resource from the Battle of Jutland has been demonstrated in this chapter. In 2001 she proved to be in a very undived condition, which can be deduced by the fact that the divers in April and May 2001 saw the ship's bell in the wreck. In my experience, such a rare item does not endure for long on any wreck that is regularly dived, especially when afforded no protection through legislation and enforcement. The second diving group actually recovered the bell and, in their own time and at their own cost, drove it to the German Naval Memorial at Laboe and donated it to the museum. This gesture was, by all accounts, gratefully received and the bell has been conserved and is now on public display (Fig. 8.10). This unique artefact had been rescued from an uncertain fate (see [Chapter 15](#)).

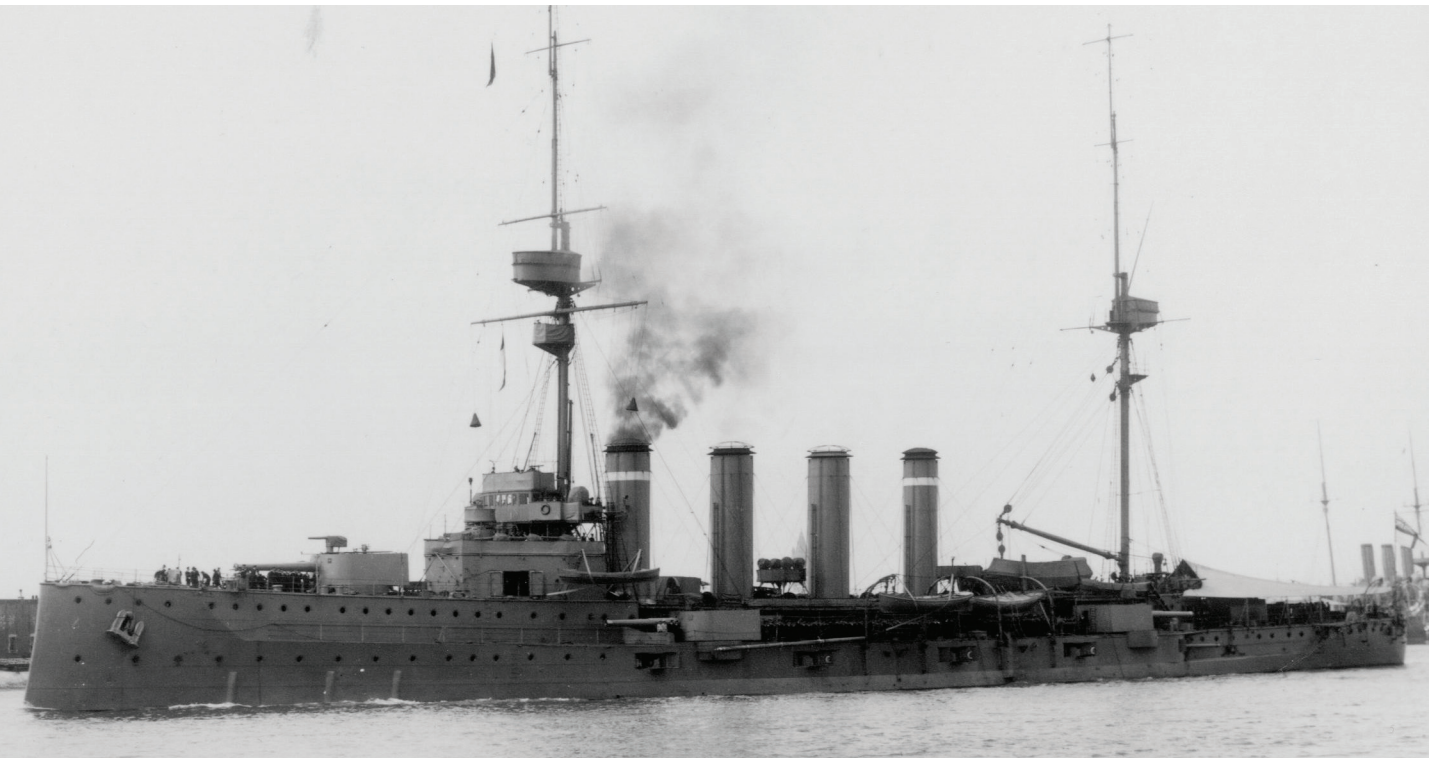
Fig. 9.1 HMS Black Prince. Launched in 1905, she had a displacement of 13,550 tons and a length of 480 ft, with six 9.2-inch guns. (Picture: Imperial War Museum Q21019)

HMS *Black Prince* (Fig. 9.1) was a companion cruiser to the pre-Dreadnought King Edward VII class of battleships. The design ethos of the armoured cruiser went through a revision when a new director of naval construction, Philip Watts, was appointed in 1902. A recognition grew that although the design was primarily for commerce protection, squadrons of armoured cruisers may eventually form battle lines in a fleet action, requiring heavier guns. This led

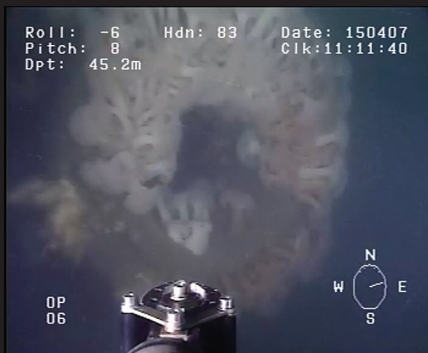
Fig. 9.6 The aft side of the bracket that held the Black Prince's starboard-side propeller as seen during the ROV survey in 2015. (Picture: McCartney/JD-Contractor)

The westerly portion of the wreck turned out to be the stern. This was confirmed when the 'A' bracket, which would have held the starboard-side propeller, was seen still in place on the hull (Fig. 9.6). The propeller had gone, but the bracket was unmistakable.

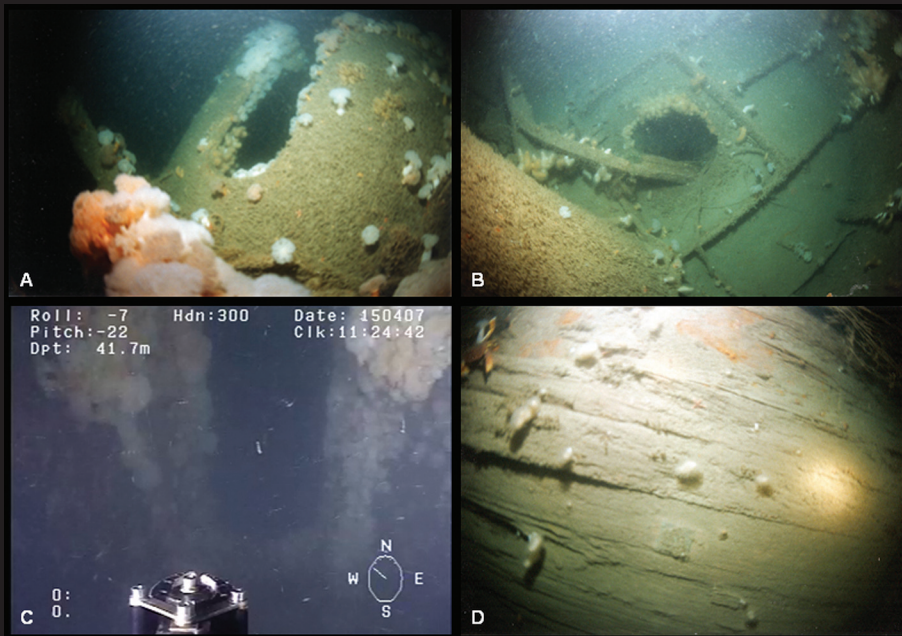
Fig. 9.7 Images showing the remains of 'X' turret: A shows that the turret is roofless and B that the gun has gone. In C, the turret points north-west. The after deck in places was observed to have its planking in good condition after 99 years of immersion in the sea. (Picture: C McCartney/JD-Contractor)

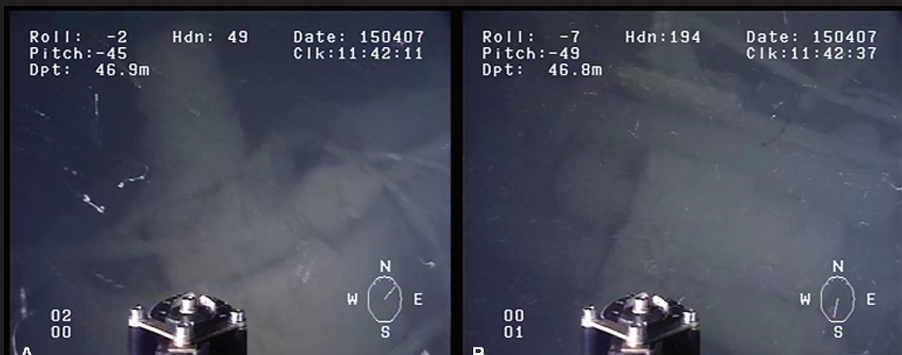
Fig. 9.8 The remains of what is most likely a 6-inch casemate gun turret upside down on the seabed are shown in A, with B showing the gun breech also upside down with its underside facing upwards. (Pictures: McCartney/JD-Contractor)

The ROV then passed along the northern side of the wreck. Among the items seen were the remains of what appears to be one of *Black Prince's* 6-inch casemate guns upside down, having apparently fallen out of the wreck. The gun was present pointing roughly north-west. The underside of the gun breech was clearly visible inboard of the casemate (Fig. 9.8).

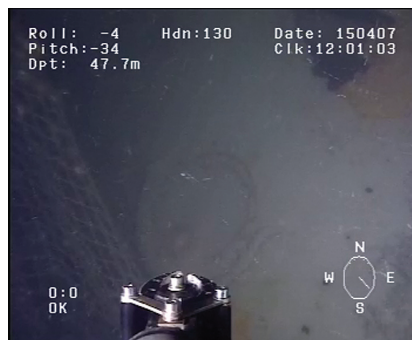
Fig. 9.10 A porthole of the type seen in the forecandle of HMS Black Prince. This area of the wreck is very rotten and in a state of collapse. (Picture: McCartney/JD-Contractor)

Moving up towards the bow, the raised forecandle deck was observed to be very rotten and collapsed. This portion of the wreck was clearly identifiable by the rotted steel plates containing portholes with their distinctive semi-circular drip shields on them (Fig. 9.10). The ROV then passed up to and around the bow and began its return run along the southerly side of the wreck.

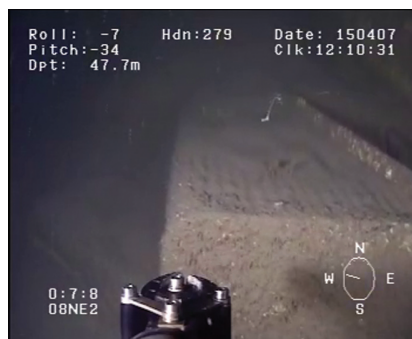
Fig. 9.11 An intact, unburned 9.2-inch cordite container on the seabed in the vicinity of 'A' turret. Its condition might indicate that the explosion that sank HMS Black Prince did not extend to 'A' magazine. (Picture: McCartney/JD-Contractor)

Much of the south side of the wreck was found to be sealed flat to the seabed. However, in line with 'A' turret next to the wreck, we found a complete, unburned cordite container for a 9.2-inch gun (Fig. 9.11). It must have fallen

there when the ship rolled over. Its unburned condition might indicate that the conflagration that destroyed the ship did not extend so far forward. The fact that the bows are not blown off, as seen on HMS *Defence*, for instance, would tend to also support the view that the explosive damage to the ship was limited to the stern.

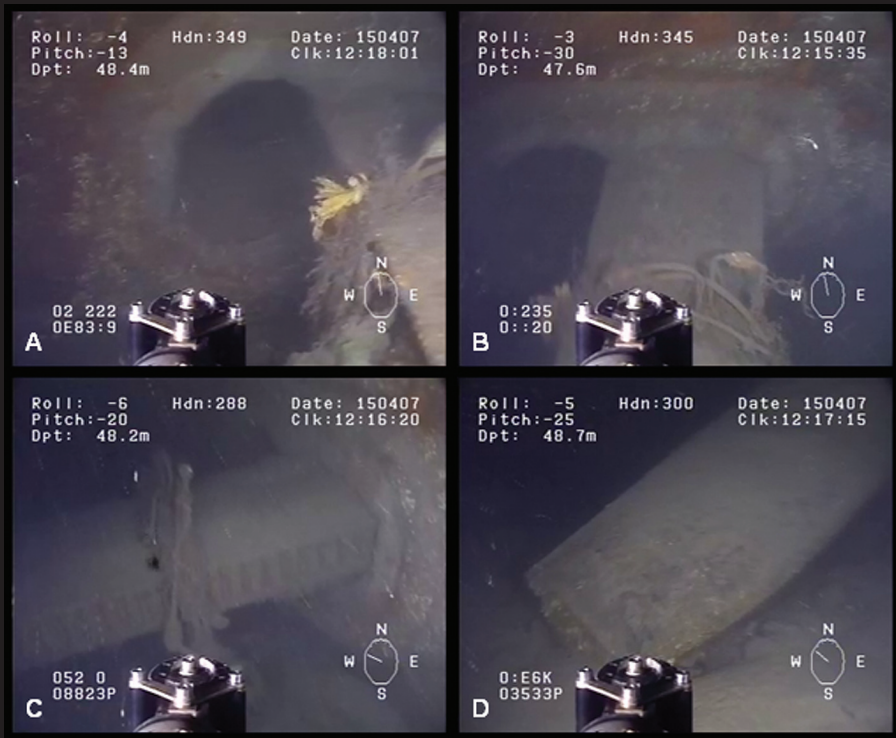
Fig. 9.12 The opened external torpedo door on the port side of HMS *Black Prince*. The tube is visible in A and B and the fin can be seen in B, C and D. The fact that this tube was readied for use, and may have fired, somewhat belies the German view that the *Black Prince* did not respond to the devastating fire she received. (Pictures: McCartney/JD-Contractor).

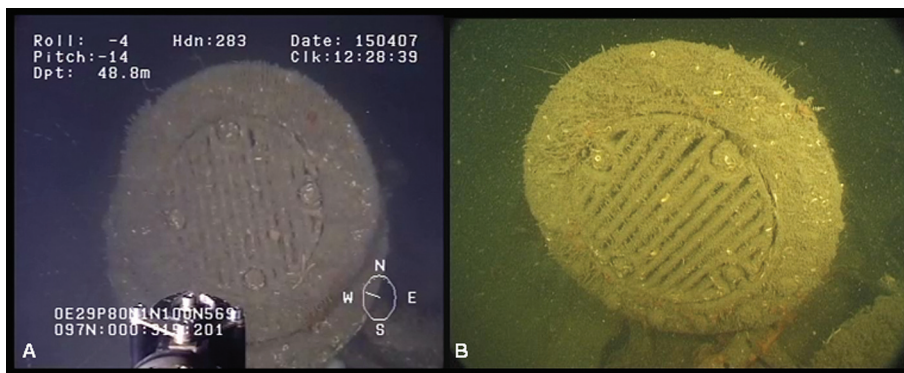
Fig. 9.16 Two deck drains seen on the wreck of the *Black Prince*: A was recorded in 2015 near the break at the aft end of the main portion of the wreck, while B was recorded in 2000 and its location remains unknown. Both are seen from the top, with the removable strainer plate clearly visible. More of the wreck's external features await recording in the future. (Pictures: McCartney/JD-Contractor)

It is far from certain that the last word has been written about this still enigmatic wreck site. Further survey work could yield more valuable information about what is present, since the 2015 ROV survey did not capture all of the wreck's key features, primarily because of poor visibility. The pair of deck drains seen in Fig. 9.16 serve to illustrate this point. While one is now mapped, the location of the other remains unknown.

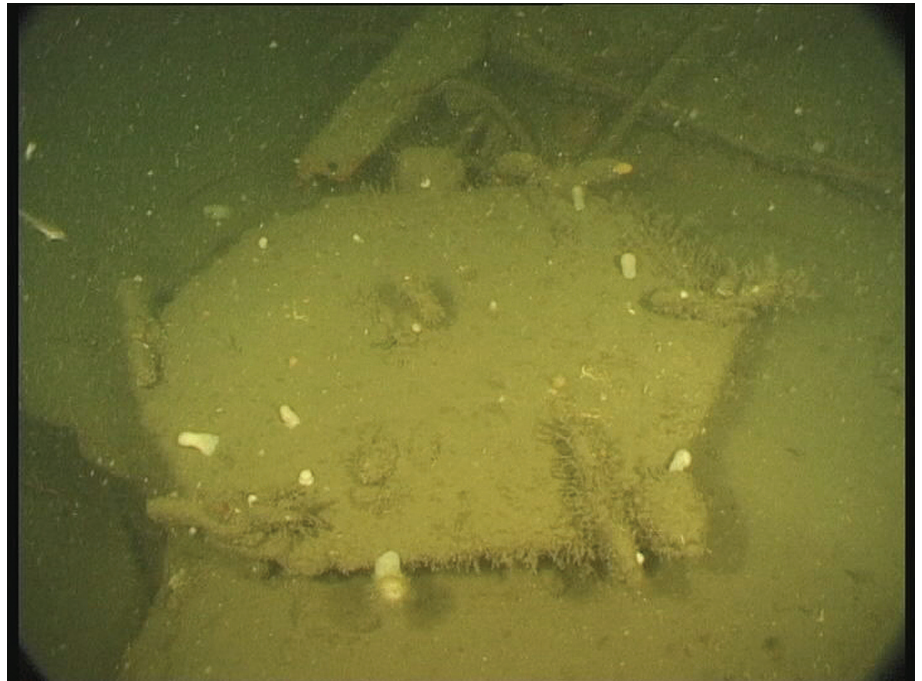
Fig 9.17 A watertight door on the wreck of the *Black Prince*, echoing the words of HMS *Chester*'s captain after the Battle of Jutland.

Such a door can clearly be seen in Fig. 9.17. It has been shut by only two of its six clips. This is a fine example of how human agency can be clearly detected in a 20th century nautical archaeology context. Moreover, the complacency that was seemingly endemic in the Grand Fleet leading up to Jutland, caused by what Gordon has termed ‘the long calm lee of Trafalgar’, is nowhere better illustrated than in that one image. Ironically, it comes from the least understood of the British shipwrecks and, if anything, tells us how much more the wrecks can yield with further research.

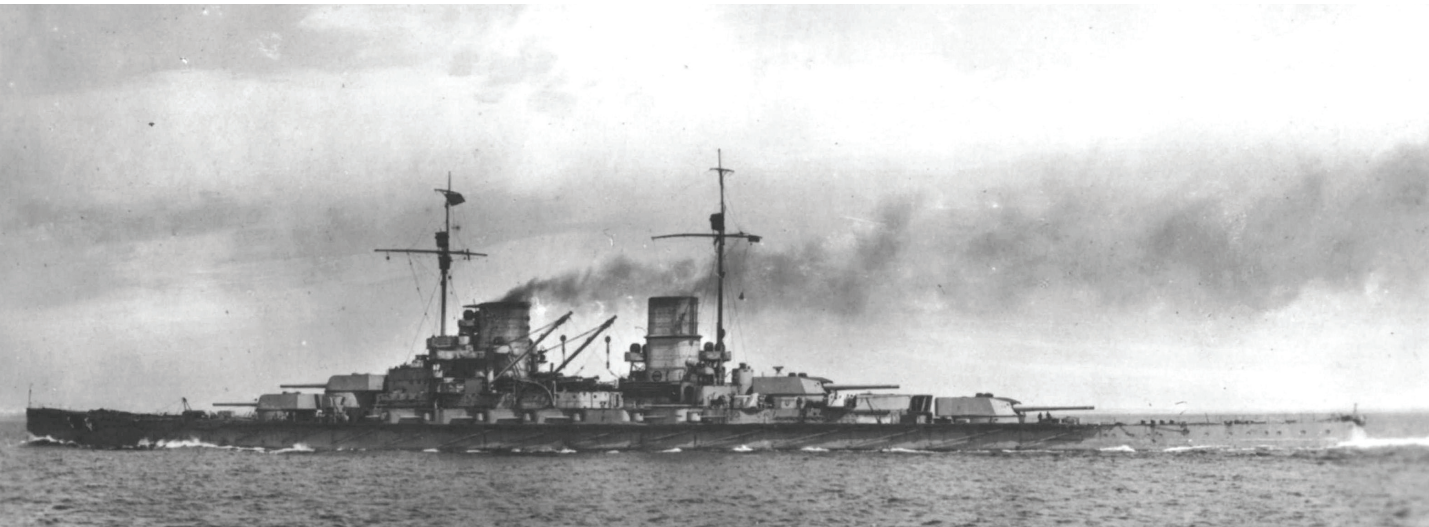
Fig. 10.1 SMS Lützow on sea trials two weeks before the Battle of Jutland. Launched in November 1913, she had a displacement of 26,318 tons and a length of 689 ft, with eight 12-inch guns and fourteen 5.9-inch guns. (Picture: Archiv Deutscher Marinebund)

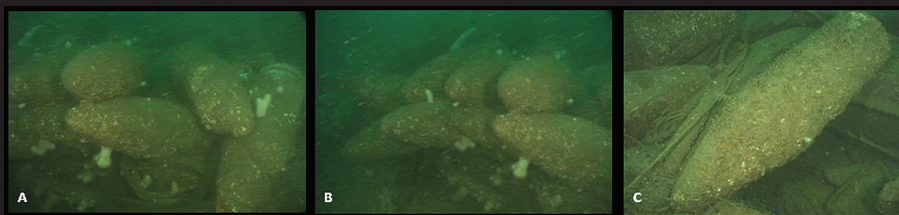
Fig. 10.5 12-inch rounds as seen on the wreck of SMS *Lützow*. All appear to be of the high explosive type. A and B show shells apparently still stacked for use, although upside down and somewhat collapsed. C shows a closer view of one shell.

Owing to the salvage works on the wreck site, much of the interior can now be seen. In places it is dominated by assemblages of ammunition and propellant for the main and secondary armament. This can be seen extensively where the hull has been cut down or has collapsed in the regions of the magazines. The types visible are shown in Fig. 10.5, Fig. 10.6 and Fig. 10.7. Fig. 10.5 shows an assemblage of 12-inch rounds as seen on an area of the wreck thought to be in the region of a shell room below 'A' or 'B' turrets. All rounds seen in this area appear to be of the high explosive type.

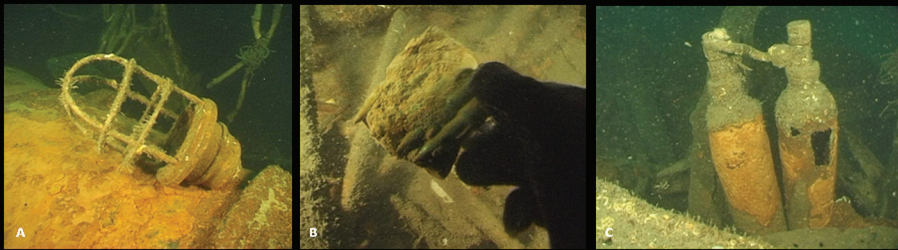
Fig. 10.9 Other notable items seen on the *Lützow* wreck: A shows a cage lamp, commonly seen on this wreck, B a clip of small arms ammunition and C gas cylinders, either from the original ship or left behind by salvage activity.

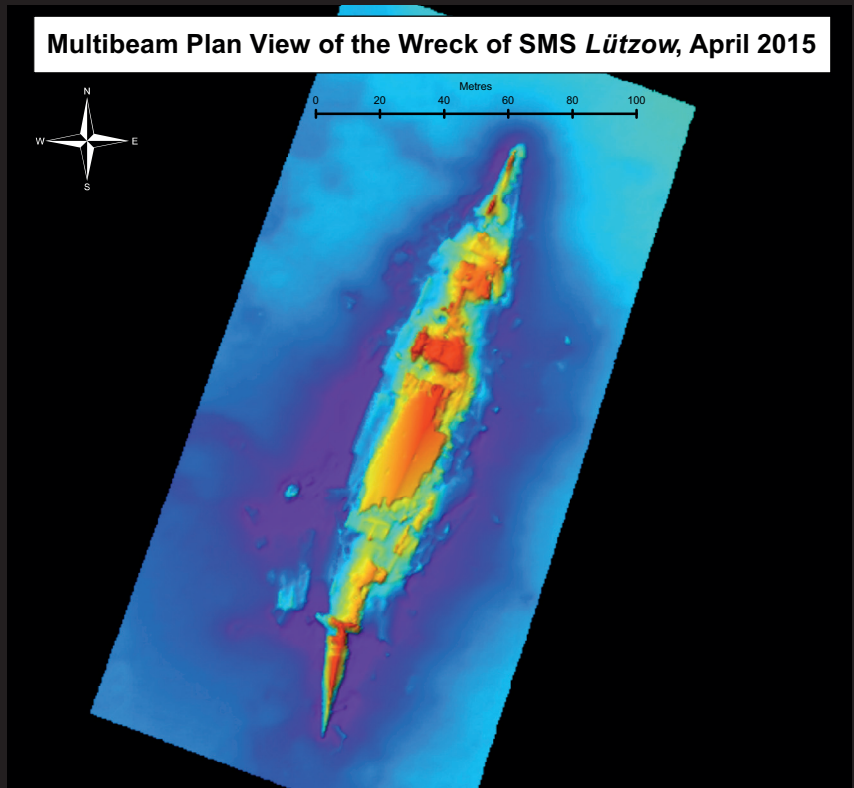
Fig. 10.10 Plan view of the wreck of SMS *Lützow*, as depicted on Vint's multibeam system in April 2015.

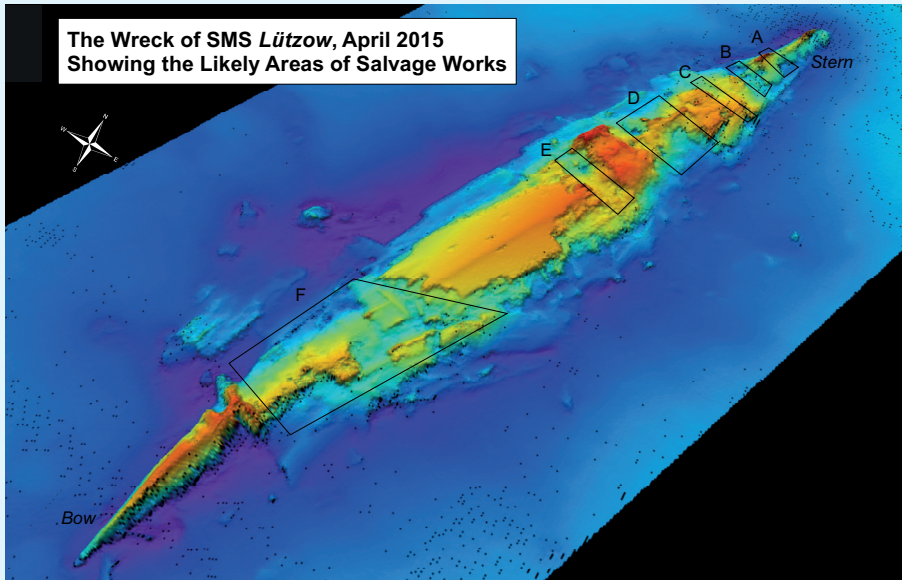
Fig. 10.11 The wreck of SMS Lützow showing the areas where it is thought commercial salvage has taken place in the past.

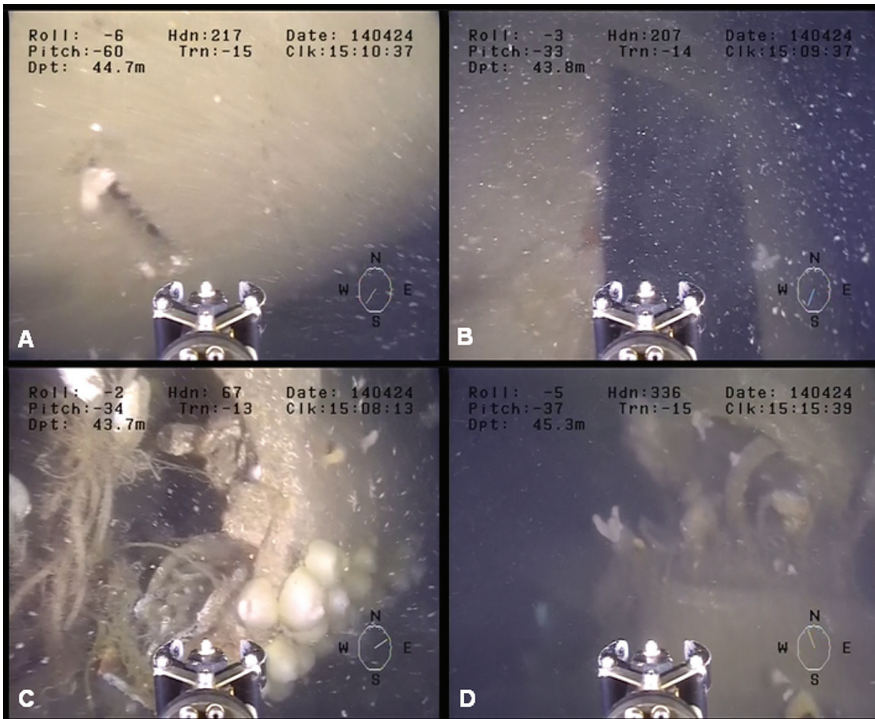
Fig. 11.5 The armored conning tower as seen on the wreck of SMS *Elbing*. A shows the side of the tower with one of its slit windows visible in the centre. B shows the access door to the rear of the tower. C shows the termination of the armored stalk of the tower. D shows the range finder snapped off its base and hanging upside down. (Pictures: McCartney/JD-Contractor)

As the ROV edged its way along the side of the wreck, the unmistakable remains of the armoured conning tower came into view. This cylindrical feature is common on German light cruisers of the First World War and its type is well known to me from similar ones seen on the light cruiser wrecks in Scapa Flow. Here the tower had fallen out of the wreck and was lying with

its top pointing down to the seabed where the range finder was still present, although it had partially split away from its mounting. The access door at the rear of the tower was now at the top and its armoured stalk, which led down to the armoured deck, was now the highest point of the feature (Fig. 11.5).

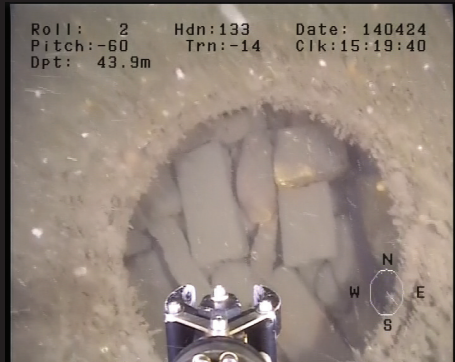
Fig. 11.8 Looking down a circular hole from the top of the wreck revealed a pile of fire bricks within. It appeared that the superstructure had in places collapsed over the internal machinery spaces of the ship. (Picture: McCartney/JD-Contractor)

The ROV survey established that the wreck was upright, although the bow area seemed damaged. Interestingly, in places the superstructure of the ship seemed to have collapsed inwardly into the hull, covering much of the machinery inside, although not all of the wreck was inspected. On the highest point of the wreck, the ROV passed over an open circular feature, either a porthole or a bulkhead cutting. Looking down into it revealed a pile of fire bricks for the boilers (Fig. 11.8).

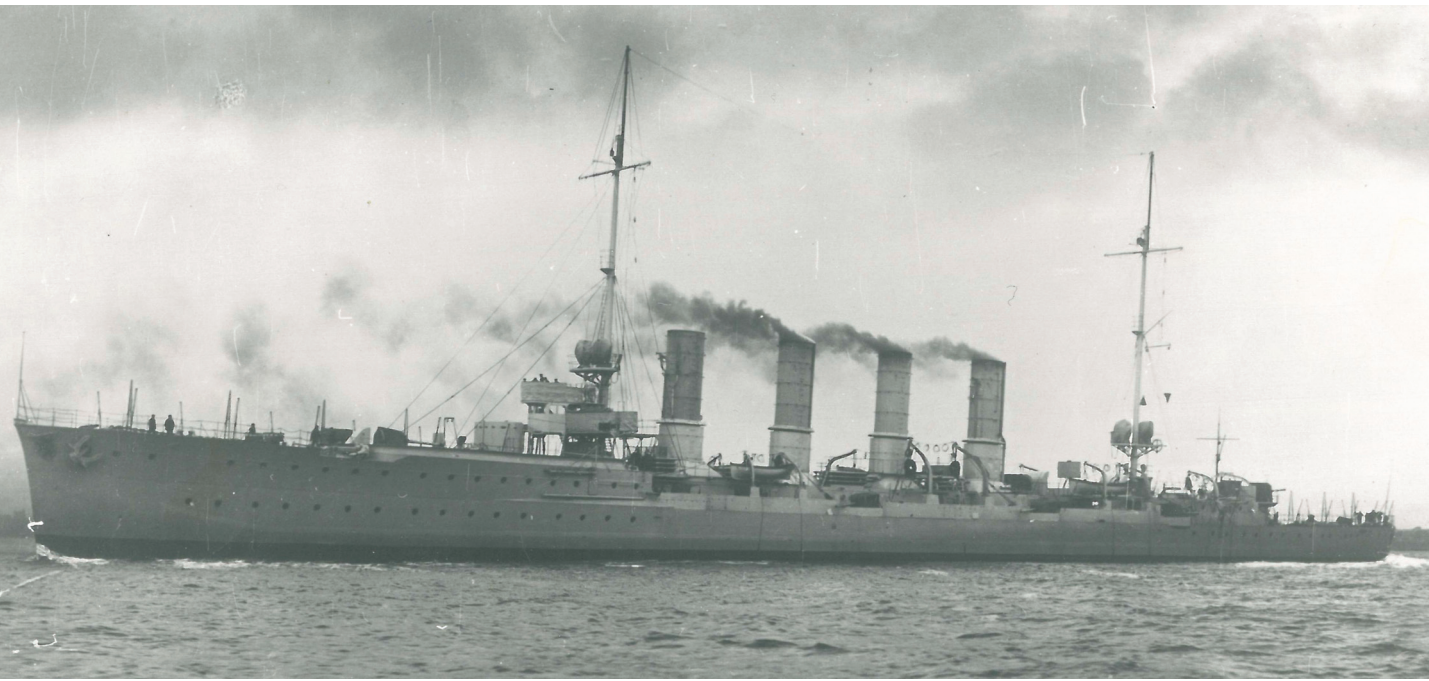
Fig. 13.1 SMS Rostock, as seen from the port side. She had twelve 4.1-inch guns on single mounts, a pair side by side forward and aft and four down each side, and two 19.7-inch submerged torpedo tubes. Launched in November 1912, she had a displacement of 4,900 tons and a length of 446 ft. (Picture: Archiv Deutscher Marinebund)

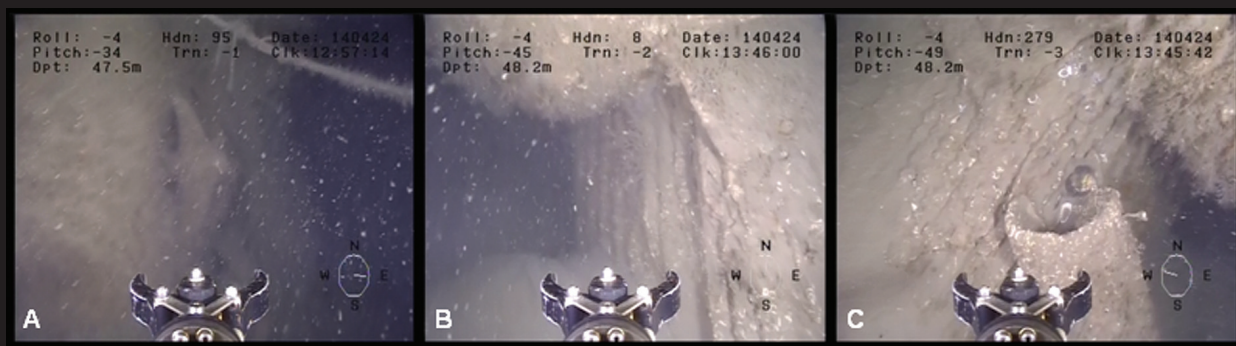
Fig. 14.5 Images of the remains of HMS *Tipperary*'s boilers, now the only recognisable features of this once powerful destroyer. (Picture: McCartney/JD-Contractor)

The ROV started the survey in the south-west area of the wreck. The dominating features were the steam drums at the top of the three-drum boilers seen on warship wrecks of this period. Fig. 14.5A shows the locking arms for the manhole cover in the steam drum. The steam drums are situated directly on the seabed and the ROV had to search carefully to find a couple of places where the water tubes could be seen projecting from the underneath of them. B and C show the water tubes as seen. The actual water troughs are buried under several feet of mud.

So the ROV tape revealed that the highest points of the wreck were the tops of the steam drums of the ship's boilers. Looking again at the multibeam images of the wreck, there seemed to be between four and six boilers present. HMS *Tipperary* was unique among all of the destroyers and torpedo boats sunk at Jutland because she was equipped with six White-Forster boilers. One feature of this boiler type is the slightly curved nature of the water tubes, but, with so little of them now showing, this was difficult to discern on the ROV tape.

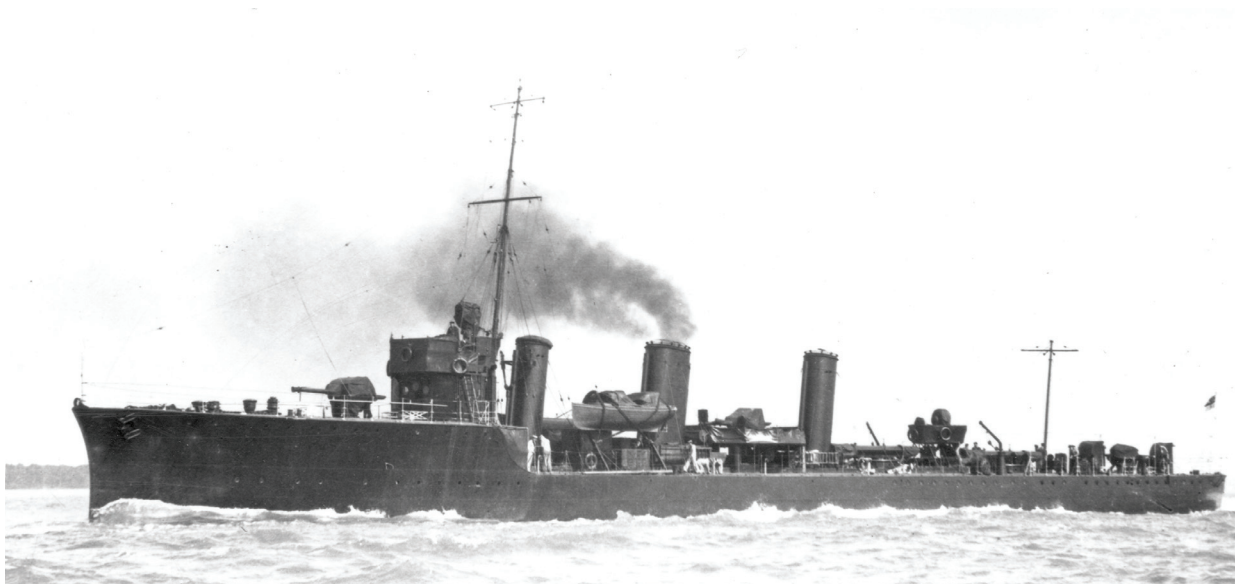
Fig. 14.7 HMS Fortune had a length of 265 ft and displacement of 981 tons, with three 4-inch guns (one forward, one between funnels No. 2 and No. 3 and one aft) and two 21-inch torpedo tubes aft of the after funnel either side of the searchlight. Note the clipper bow. The rest of the 'K's had a straight stem. (Picture: Richard Osborne Collection)

HMS *Fortune* (Fig. 14.7) was of the Acasta, or K, class of British destroyers of 1911–12. Uniquely among the destroyers and torpedo boats lost at Jutland, most of this class was fitted with four boilers. During the Night Action, two of her sister ships, HMS *Ardent* and HMS *Sparrowhawk*, were also sunk. However, both the *Fortune* and the *Ardent* were not typical ‘Ks’; they were considered ‘specials’.¹⁷ In the case of HMS *Fortune*, she was the only one of her class built by Fairfield in Govan. She was unique in appearance for a ‘K’, having a clipper bow, a gun between No. 2 and No. 3 funnels, a searchlight platform between the torpedo tubes mounted aft of the funnels and all of her funnels of equal height.¹⁸ She was, in fact, built as a ‘try-out’ for the three-funnel version of the future ‘L’ class.

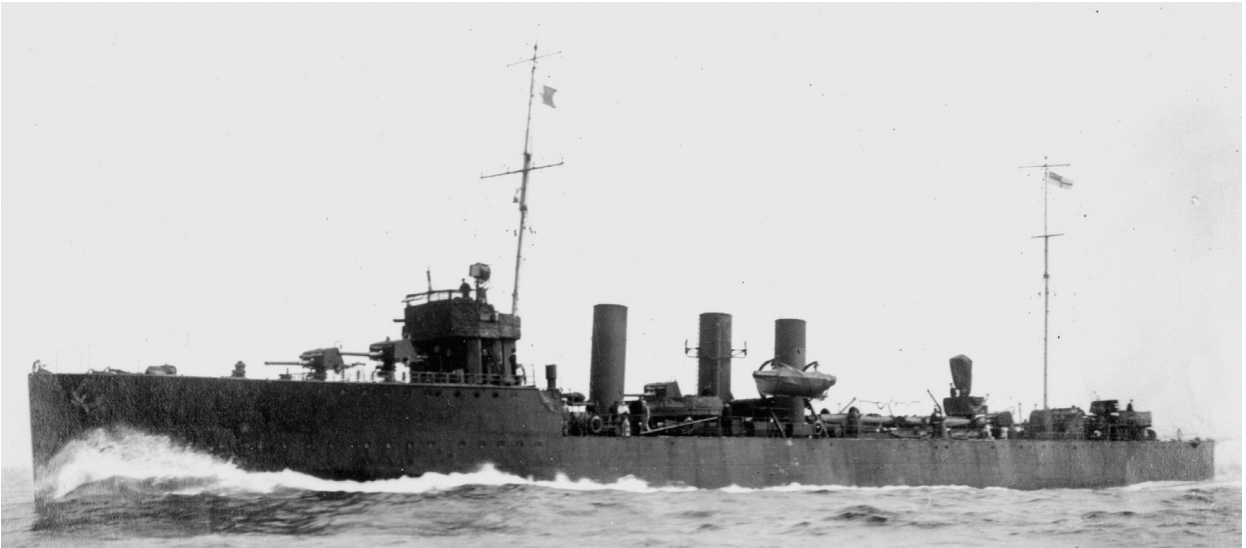
Fig. 14.14 HMS *Turbulent* had a length of 309 ft and a displacement of 1,098 tons, with five 4-inch guns (two on the forecastle wings, one between the funnels, one on the upper deck aft and one on a platform aft) and four 21-inch torpedo tubes in double mounts aft of the funnels. (Picture: Richard Osborne Collection)

HMS *Turbulent* (Fig. 14.14) was also of a unique design among the destroyer wrecks sunk during the Battle of Jutland. Like the *Tipperary* which was taken over while being built for Chile, *Turbulent* was one of four destroyers being

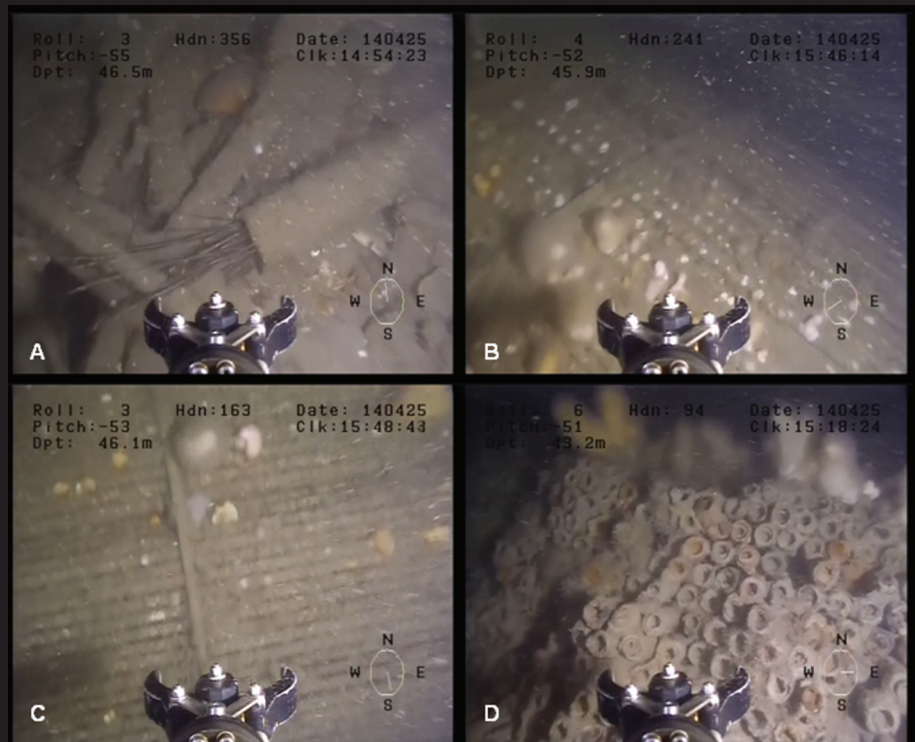
Fig. 14.16 Features seen on the HMS *Turbulent* wreck, confirming her nationality and perhaps confirming the boiler explosion described by Groos. (Pictures: McCartney/JD-Contractor)

JD-Contractor had looked at this site with an ROV on the afternoon of 24 April 2014 and we consulted the tape for evidence. The conditions were as poor as on the *Ardent*, with underwater visibility not much more than one metre. Nevertheless, enough could be seen to confirm the wreck to be British and to assist in explaining what may have happened to her. Some images from the ROV survey are shown in Fig. 14.16. The survey began at the south-westerly point of the wreck, which turned out to be the stern. The highest point was the bent rudder pin. Around it lay a number of 4-inch shell cases.

The shell case (Fig. 14.16A) had the British type of ‘spaghetti’ sticks of cordite projecting from the open end. As the ROV passed over the area of the engine room the unmistakable shape of a condenser was seen (B and C), with its tightly bundled copper tubing and overall shape similar to the British design. Finally as the ROV worked its way forward, it found a boiler (D) in a similar condition to those seen on the wrecks of SMS V27 and V29 (which the *Turbulent* had helped to sink, see [Chapter 3](#)), with the steam drum gone and only the piping leading upwards from the water troughs visible.

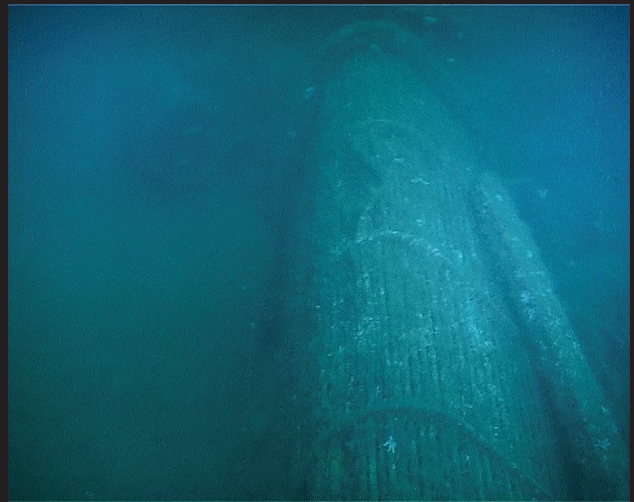
Fig. 15.5 The top of one of HMS *Nomad*'s condensers, as seen in 2002 by Kevin Pickering. This item was not located in 2014 or 2015 and has probably been taken from the wreck site and melted down for profit. (Picture: Kevin Pickering)

The greatest surprise of the 2015 multibeam survey was the number of the small wrecks that were located. The second greatest surprise was to see how many of them had already lost their condensers. These wrecks have been coming to light only in the last decade or so and they already bear the scars of salvage for profit. They represent a second wave of salvage at Jutland which is unlikely to stop without some form of monitoring and enforcement. The question is: enforcement of what and by whom?
